INDOOR AIR QUALITY ASSESSMENT

**Wellesley Middle School
50 Kingsbury Street
Wellesley, MA**

Prepared by:
Massachusetts Department of Public Health
Bureau of Environmental Health
Indoor Air Quality Program
February 2020

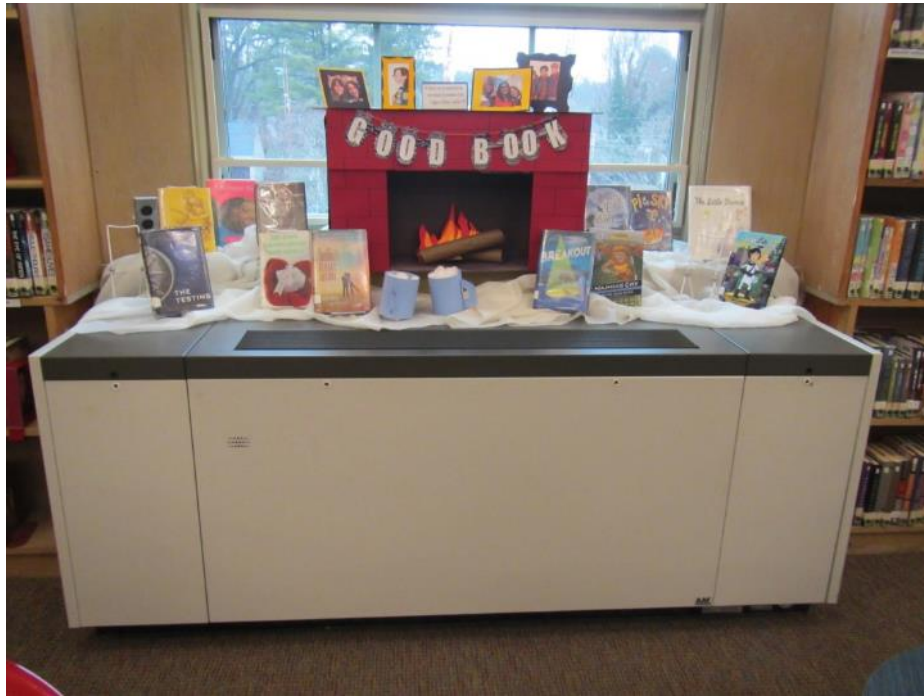
Picture 1

The WMS has a combination of HVAC equipment. Most classrooms are equipped with unit ventilators (univents, Picture 1). A univent draws fresh air through a vent on the exterior wall (Picture 2). Air is mixed with return air from the room, filtered, heated (if needed) and delivered to the room ([Figure 1](#)). Both the top and the vent at the bottom need to be kept clear of obstructions for the units to operate as designed. Some offices and common areas of the school (e.g., gymnasium, auditorium) have fresh air supplied through ceiling-mounted vents from air handling units (AHU) located in utility rooms or above ceilings.

Unit ventilator

3. Remove furniture and items blocking the front and top of univents.
4. Remove furniture and items blocking exhaust vents. Consider closing classroom doors for most efficient exhaust vent function and accurate thermostat readings.

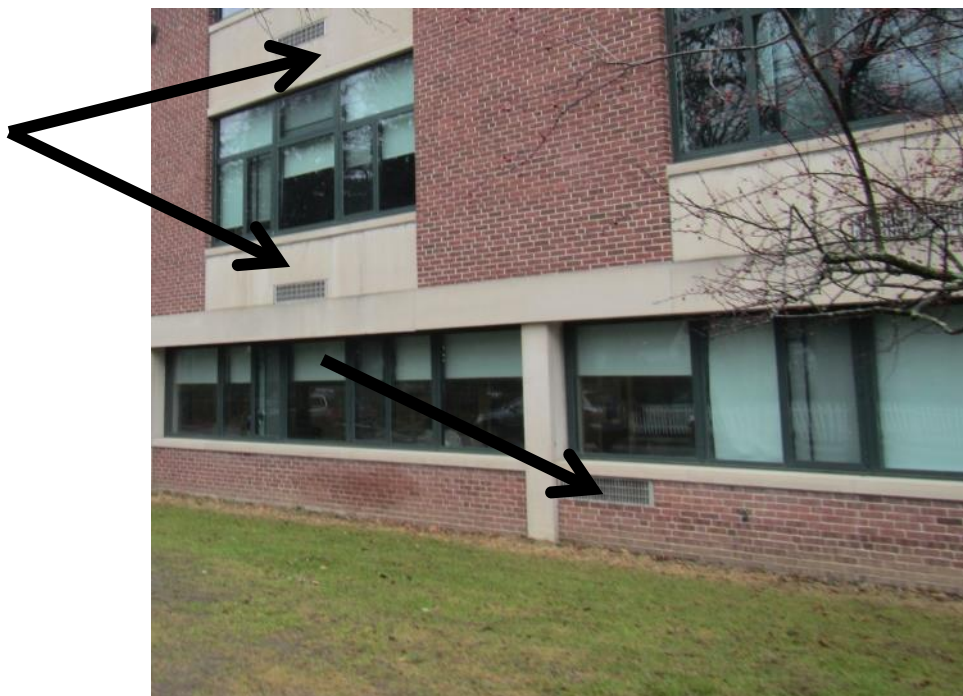
Picture 2

Univent air intakes (arrows)

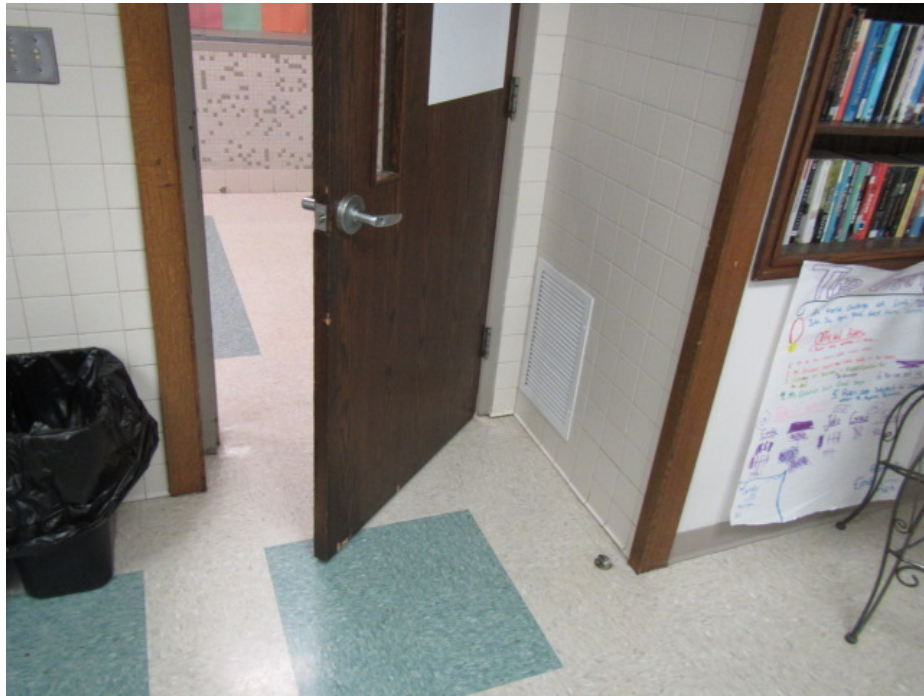
Picture 3

Exhaust ventilation for rooms with univents is supplied by wall-mounted vents (Picture 3) or exhaust “cubbies” (Picture 4). The “cubby” type exhausts are found in the oldest parts of the school, and were probably originally designed to use the stack effect to draw heated stale air up and out of the building. Currently, both types of vents are connected to fans on the roof. Most wall-mounted exhaust vents tested were drawing air; however air flow could not be detected through the older “cubby” style vents. Rooms with air supplied by AHU typically have ceiling-mounted exhaust vents (Picture 5). At the time of the assessment, commissioning work was being performed on the exhaust system to identify and repair non-functioning exhaust vents.

Wall-mounted exhaust vent

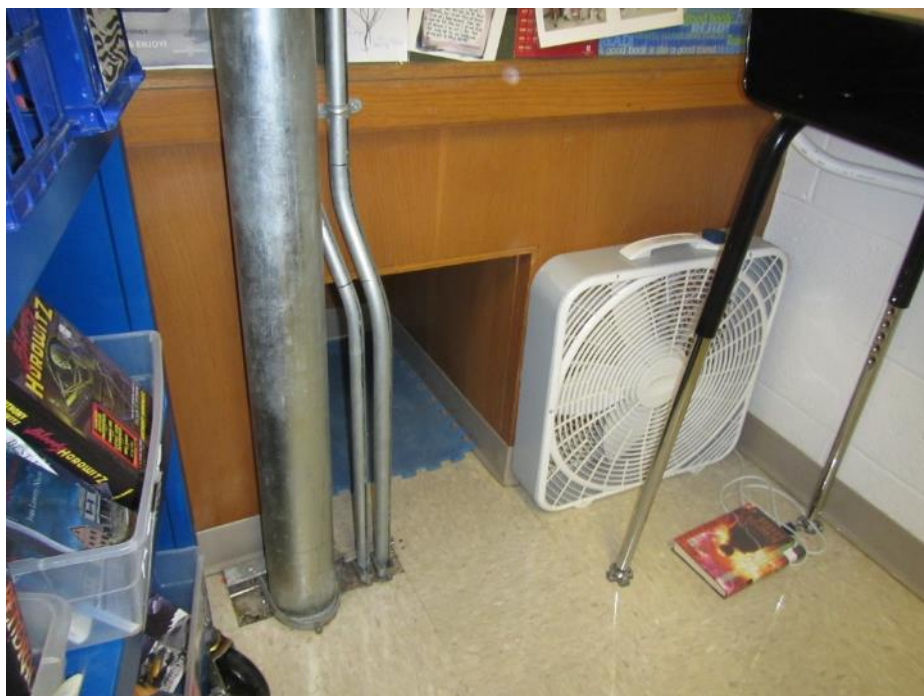
Picture 4

Exhaust "cubby"

5. Continue with exhaust vent commissioning. Periodically check exhaust vents for draw of air, particularly in high-pollutant areas such as restrooms.
6. For occupied rooms without a source of supply and exhaust ventilation or an openable window, consider methods to add mechanical ventilation.

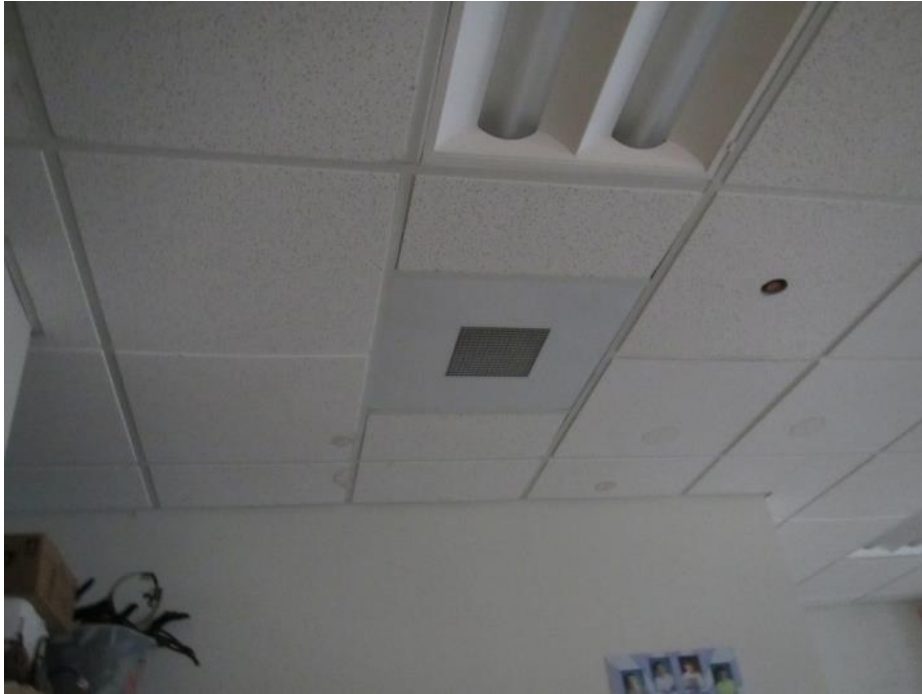
Picture 5

Ceiling-mounted return/exhaust vent

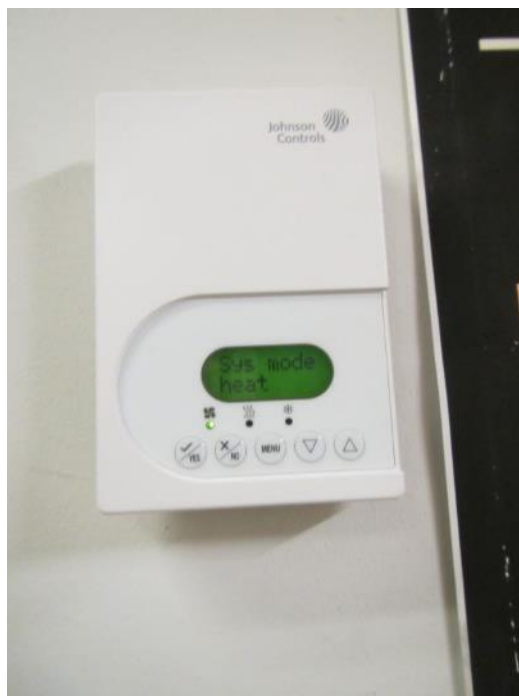
Picture 6

Typical thermostat

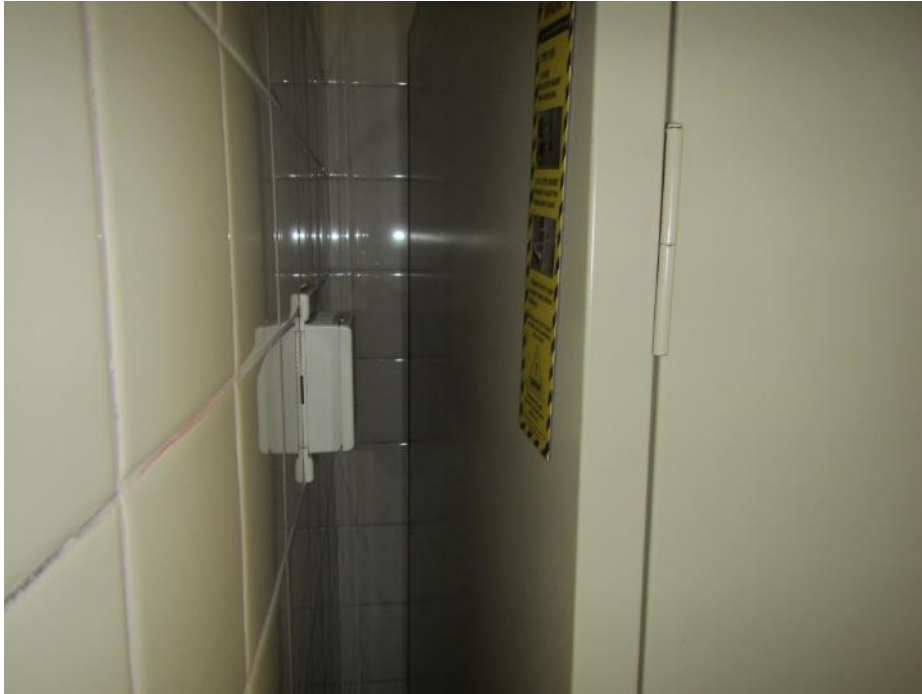
Picture 7

accurate reading of room temperature (Picture 7). Occupants should work with facility staff to properly adjust heat and ventilation to a comfortable range.

Thermostat behind furniture

9. Ensure staff are aware of the location and function of thermostats. Remind staff not to tamper with thermostats (e.g., with a wet paper towel) and to keep them clear of large furniture and other obstructions.

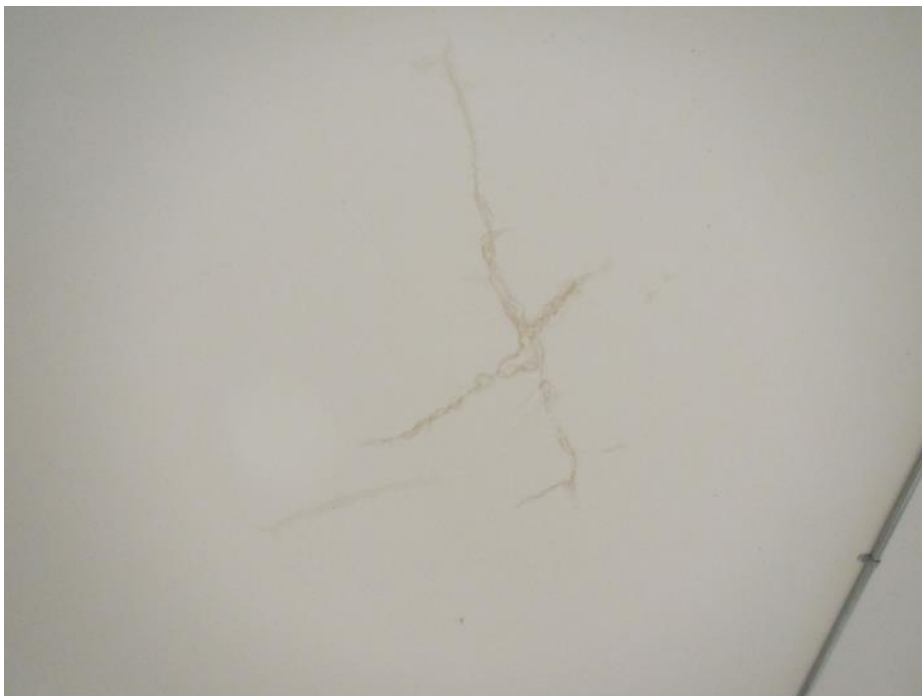
Picture 8

In order for building materials to support mold growth, a source of water exposure is necessary. Identification and elimination of the source of water moistening building materials is necessary to control mold growth. Water-damaged ceilings/tiles were observed in some classrooms and offices (Table 1; Pictures 8 and 9), which can indicate current/historic roof/plumbing leaks or other water infiltration. Water-damaged ceiling tiles can provide a source of mold and should be replaced after a water leak is discovered and repaired. The United States Environmental Protection Agency (US EPA) and the American Conference of Governmental Industrial Hygienists (ACGIH) recommend that porous materials be dried with fans and heating within 24 to 48 hours of becoming wet (US EPA, 2008; ACGIH, 1989). If porous materials are not dried within this time frame, they should be removed and discarded.

Water-damaged ceiling plaster

10. Consider adding additional heating to the stairwells at the end of wings to help address temperature concerns in nearby classrooms.
11. Replace water-damaged ceiling tiles once a leak is discovered and repaired. Ensure that dust from cutting ceiling tiles is cleaned promptly.

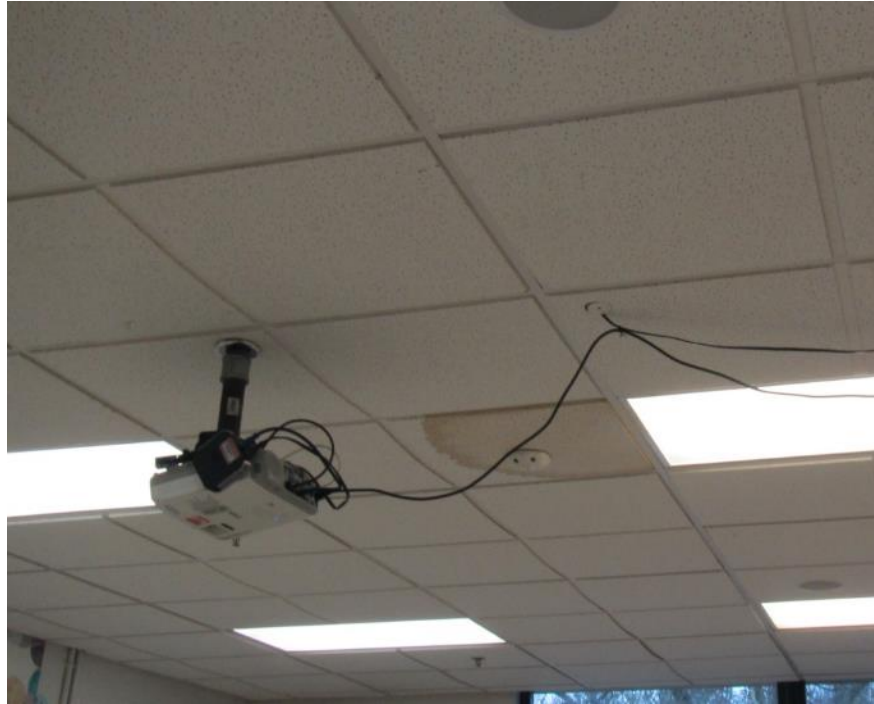
Picture 9

Water-damaged ceiling tile

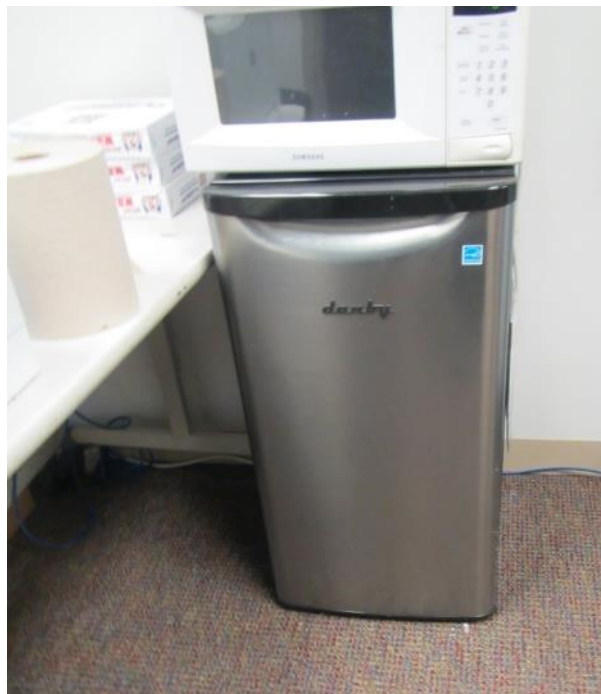
Picture 10

The refrigerator in the staff lunchroom had evidence of a spill (Table 1). Refrigerators should be cleaned out regularly to prevent odors and microbial growth. Stained gaskets should be cleaned with a mild antimicrobial solution; if they are too heavily stained/damaged, they should be replaced. Refrigerators should not be placed on carpet/porous materials (Picture 10) to protect carpets from spills.

Refrigerator on carpet

14. Ensure aquariums are clean and odor free.
15. Ensure all refrigerators are kept clean to prevent microbial growth and odors. Clean gaskets and other surfaces with a mild antimicrobial solution to remove debris and mold. If gaskets cannot be adequately cleaned, replace them.

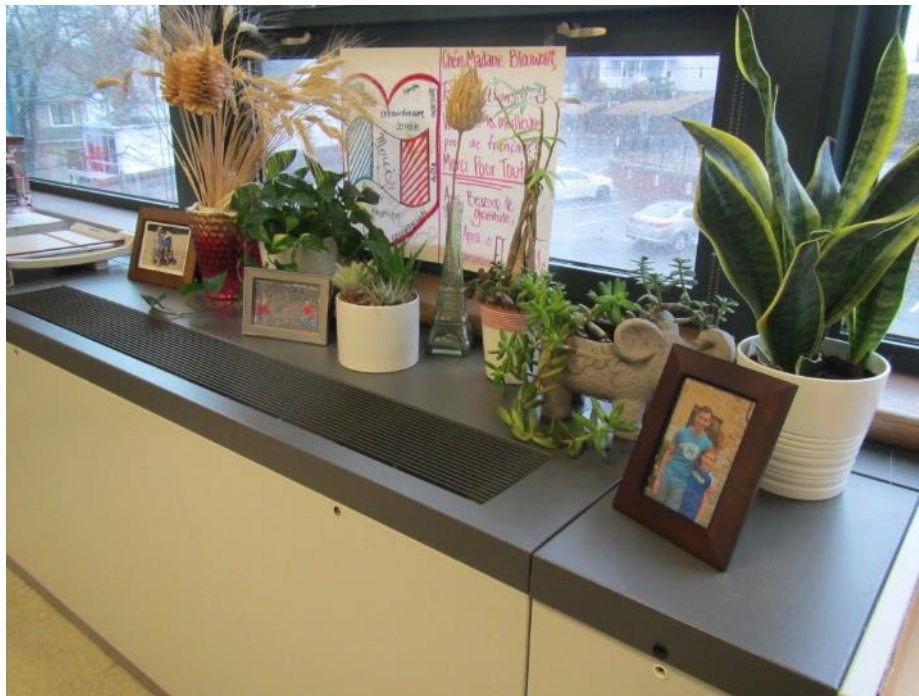
Picture 11

Plants were present in some classrooms and other areas (Picture 11). Plants should be well maintained, not overwatered, and not placed on porous materials or in the airstream of ventilation equipment. A few aquariums were observed in the building (Picture 12). Aquariums should also be kept in good condition to prevent mold/odors.

Plants on a univent

12. Replace any missing or ajar ceiling tiles to avoid pathways to unconditioned areas.
13. Keep classroom/office plants in good condition, avoid overwatering, and keep them away from the airstream of ventilation equipment.

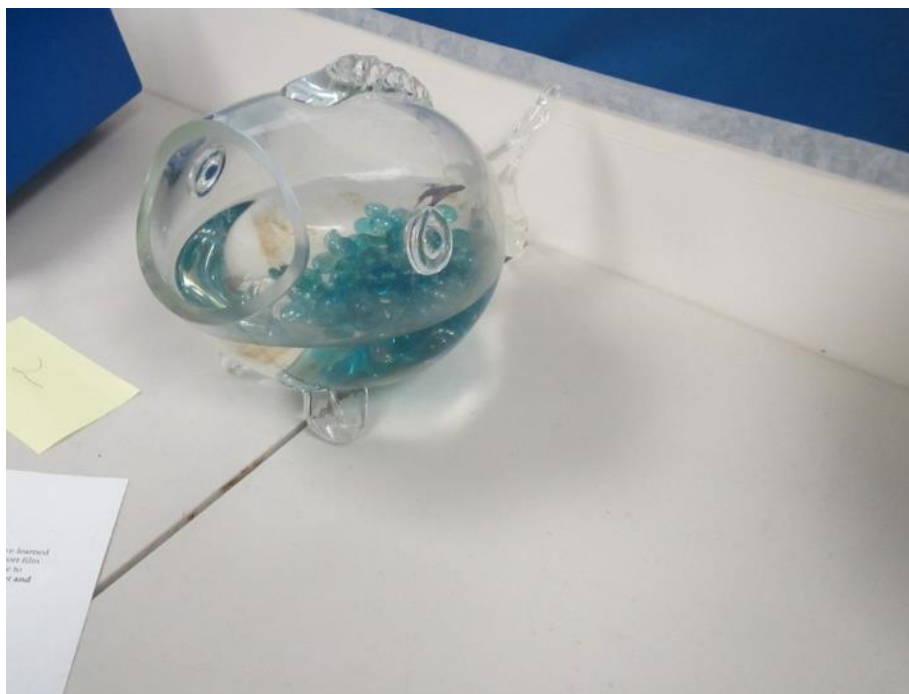
Picture 12

Aquarium

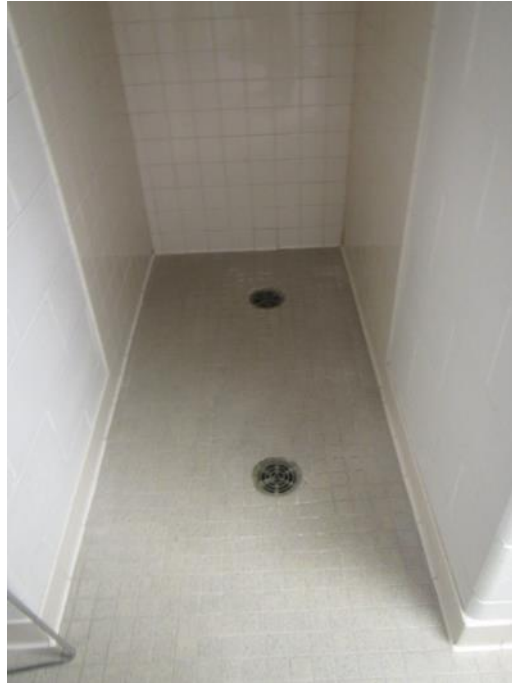
Picture 13

A sewer gas odor was detected in the boys' locker room (Table 1). Since showers in this area are seldom used, the drain traps can dry out and allow gases and odors from the drainage system into the room (Picture 13). Similar issues are reported to occur in the coaches' office area which has a shower now being used for equipment storage. Drain traps should be filled with water regularly to ensure a good trap seal. If floor drains are no longer needed, they should be properly sealed.

Drains in seldom-used shower area

16. Ensure that unused plumbing, including floor drains, are either regularly maintained to keep the traps seals wet, or are properly cut and capped. Pour water down drains on a weekly basis, or as needed to prevent dry drain traps/sewer gas odors.

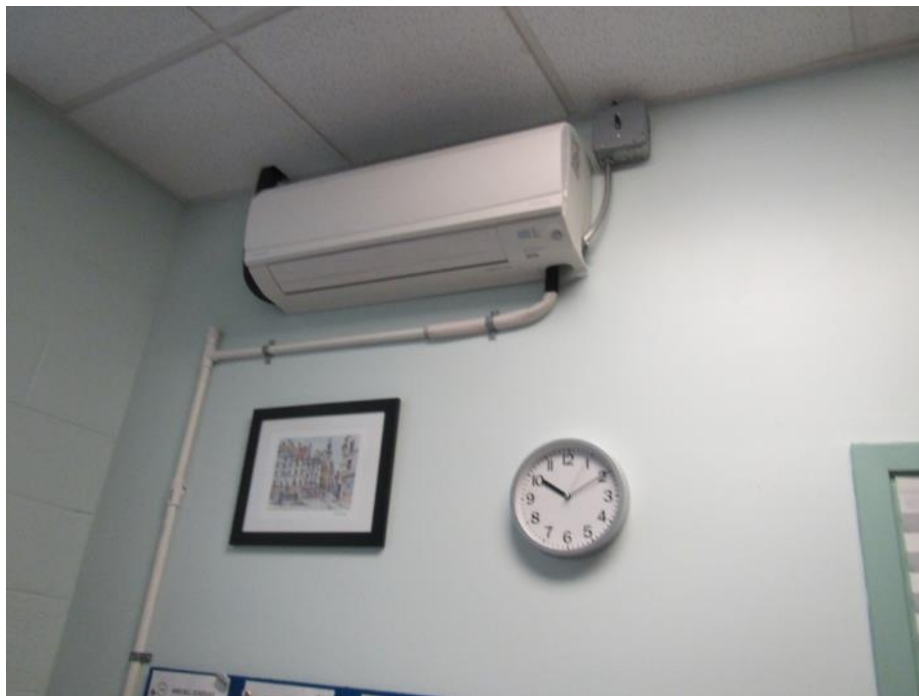
Picture 14

Ductless and portable air conditioning units (Picture 14), found in some areas of the building, create condensation. The drains from these units should have appropriate drainage, and the drain lines and pumps should be checked periodically for clogs and leaks.

Ductless air conditioner

17. Check the drain tubing and pumps on ductless air conditioners periodically for clogs and leaks.

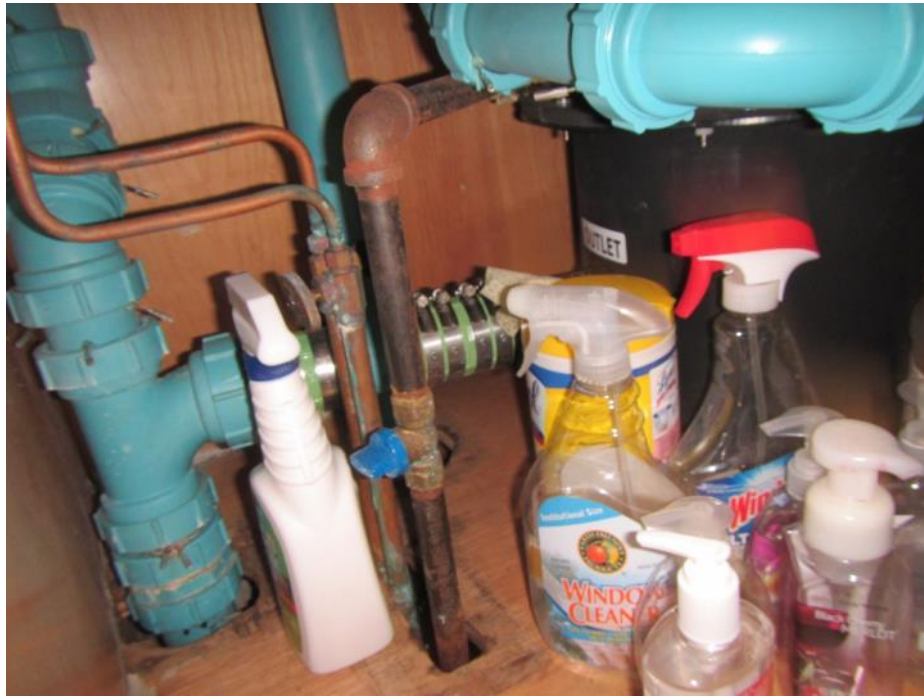
Picture 15

Exposure to low levels of total volatile organic compounds (TVOCs) may produce eye, nose, throat, and/or respiratory irritation in some sensitive individuals. BEH/IAQ staff measured TVOCs in the photography/darkroom area, and none were detected. BEH/IAQ staff also examined rooms for products containing VOCs and noted hand sanitizers, scented products, plug in air fresheners/diffusers (Picture 15), home cleaning products, and dry erase materials in use

Hand sanitizer and cleaning products

20. Reduce or eliminate the use of air fresheners, scented cleaners, hand sanitizers and dry erase materials to reduce irritation.
21. Ensure local exhaust vents for Darkroom are drawing air prior to developing processes.

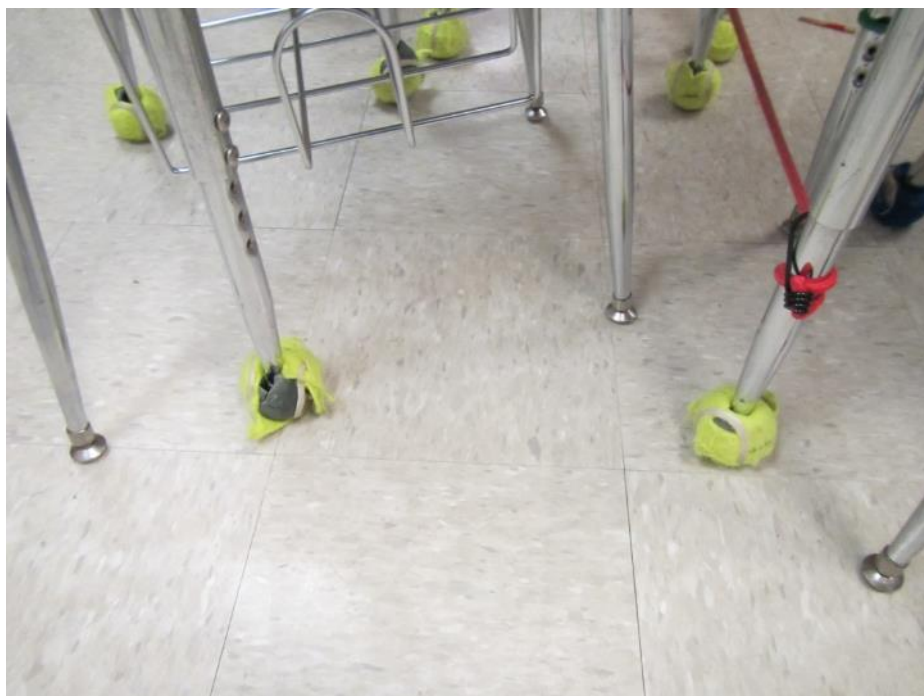
Picture 16

In some classrooms, tennis balls were being used as chair glides. Regular tennis balls contain latex. However, the blue coloration of most of the tennis balls noted in the building may indicate that they are latex-free chair glides specially designed for use in classrooms. Regular tennis balls, which were seen in a few rooms (Picture 16), are made of a number of materials that are a source of respiratory irritants. Constant wearing of tennis balls can produce fibers and lead to off-gassing of VOCs. Tennis balls are made with a natural rubber latex bladder, which becomes abraded when used as a chair leg pad. Use of tennis balls in this manner may introduce latex dust into the school environment. Some individuals are highly allergic to latex (e.g., spina bifida patients) (SBAA, 2001). It is recommended that the use of materials containing latex be limited in buildings to reduce the likelihood of symptoms in sensitive individuals (NIOSH, 1998).

Tennis balls (yellow) on chair legs

26. Consider adding exhaust ventilation to the production room.
27. Check if blue tennis ball/glides on chair legs are latex free and replace those that may contain latex with non-latex glides.

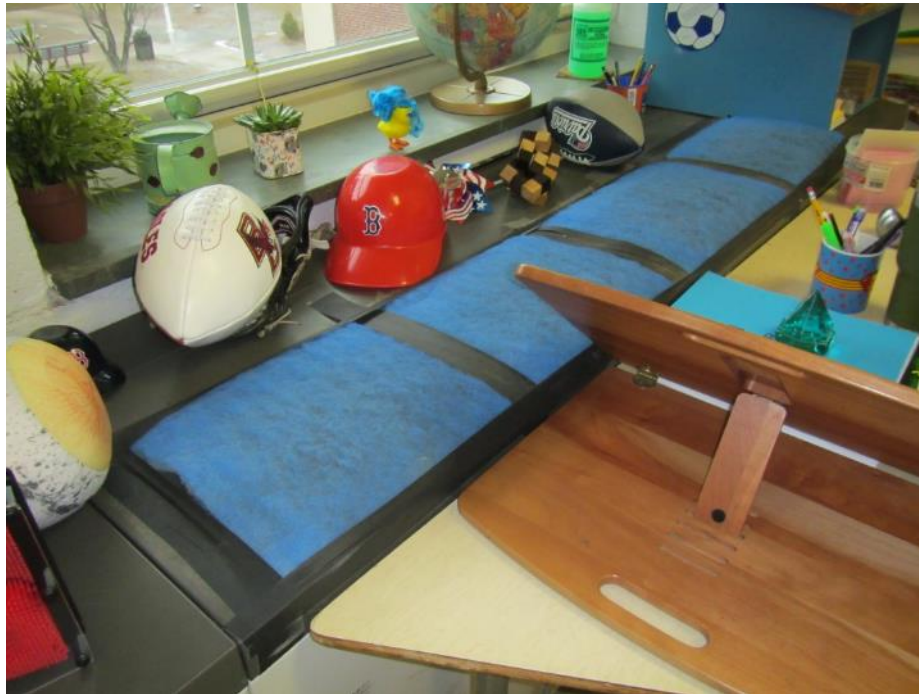
Picture 17

The MDPH recommends pleated filters with a Minimum Efficiency Reporting Value (MERV) of 8, which are adequate in filtering out pollen and mold spores (ASHRAE, 2012). Filters should also be changed two to four times a year, or per the manufacturer's recommendations. Facility staff report that filters are changed at least three times a year and the cabinets vacuumed at those times. Boxes of MERV 8 filters were found in the facility. In a few classrooms, extra external filters were placed on top of the univent supply vent (Picture 17).

These filters were installed in order to address concerns regarding dust from the supply vent. It is reportedly planned to thoroughly clean the less accessible parts, which requires removing most of the univent from the wall, during the next maintenance cycle to see if this addresses dust concerns. Insulation on the inside of the unit may be disintegrating, which may account for dust/debris seen from the units. Note that the use of these external filters may be impeding airflow from these units.

Extra filter on a univent

28. Continue to change filters in HVAC units at least twice a year with MERV 8 or higher filters. Clean HVAC and univent cabinets of debris and dust when filters are changed.

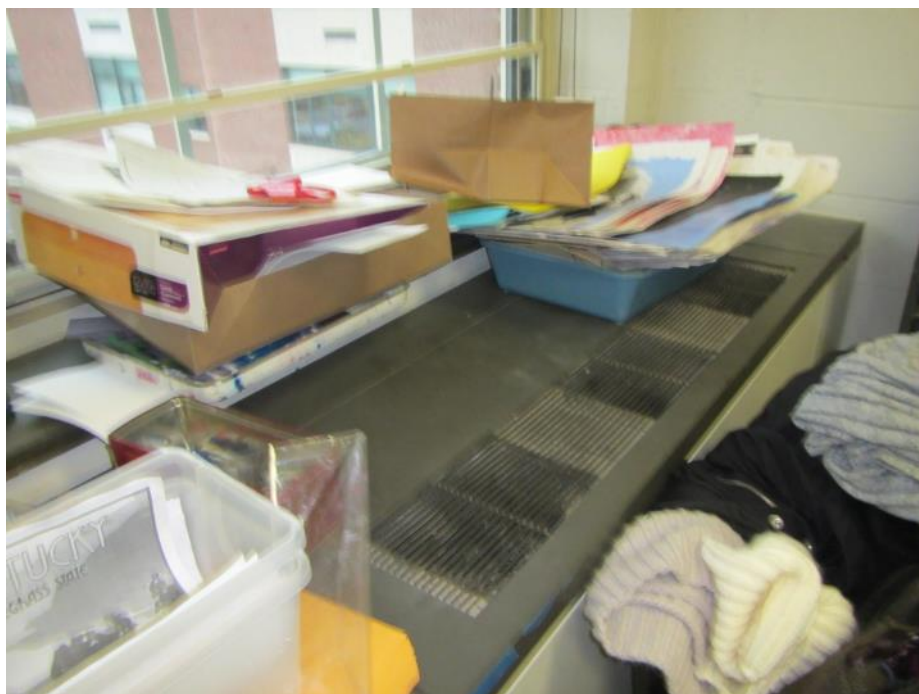
Picture 18

In many classrooms, large numbers of items were on floors, windowsills, tabletops, counters, bookcases and desks, which provide a source for dusts to accumulate (Picture 18). These items (e.g., papers, folders, boxes) make it difficult for custodial staff to clean. Items should be relocated and/or be cleaned periodically to avoid excessive dust build up. In addition, dust and debris can accumulate on flat surfaces (e.g., desktops, shelving and carpets) in occupied areas and subsequently be re-aerosolized causing further irritation. Pencil shavings were seen on surfaces (Picture 19), which can be a source of irritating dusts.

Items on surfaces and dust and debris

32. Relocate or consider reducing the amount of materials stored in classrooms to allow for more thorough cleaning of classrooms. Clean items regularly with a wet cloth or sponge to prevent excessive dust build-up.

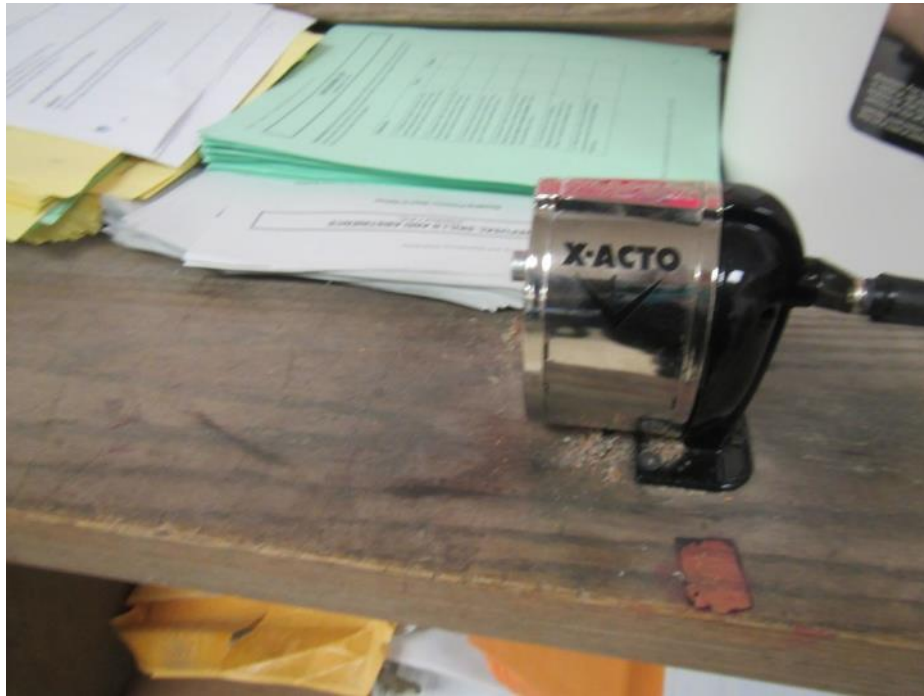
Picture 19

Pencil shavings

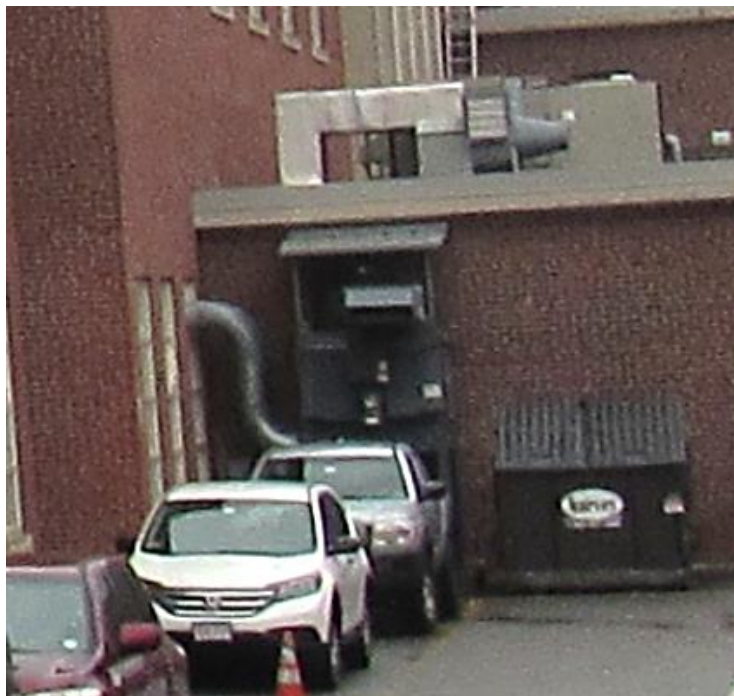
Picture 20

The shop/technology area was equipped with several local exhaust options to collect wood dust from equipment as well as the general exhaust system. In some areas the exhaust ducts all connect via vacuum with a collection system outdoors (Picture 20), which is preferable. Other areas are outfitted with a wood dust collection system that is located indoors (Picture 21) (i.e., filters and returns air to the room). Both areas are supplemented by air filtration units (Picture 22) and local exhaust fans (Picture 23) to assist in capturing fugitive dusts. These local exhaust units need to be turned on whenever the equipment is operating along with the room

Outside wood dust collection system

24. Ensure soldering materials in use are lead-free.
25. Ensure wood dust collection units, air filters and local exhaust fans are turned on whenever the equipment is operating. The collection system should be emptied and maintained regularly to prevent a build-up of wood shavings and filters should be changed per manufacturer recommendations.

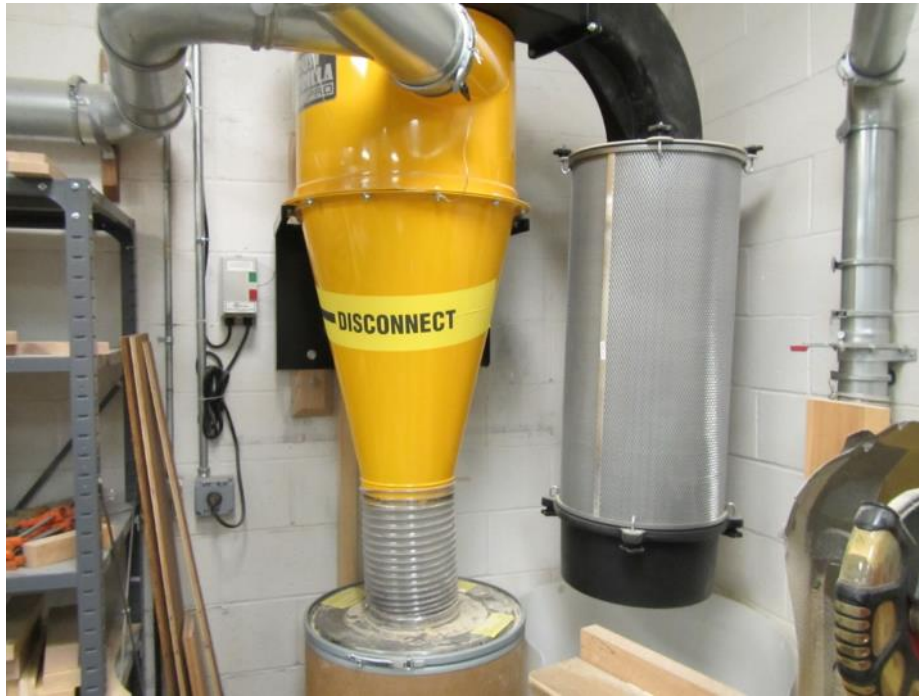
Picture 21

Interior wood dust collection system

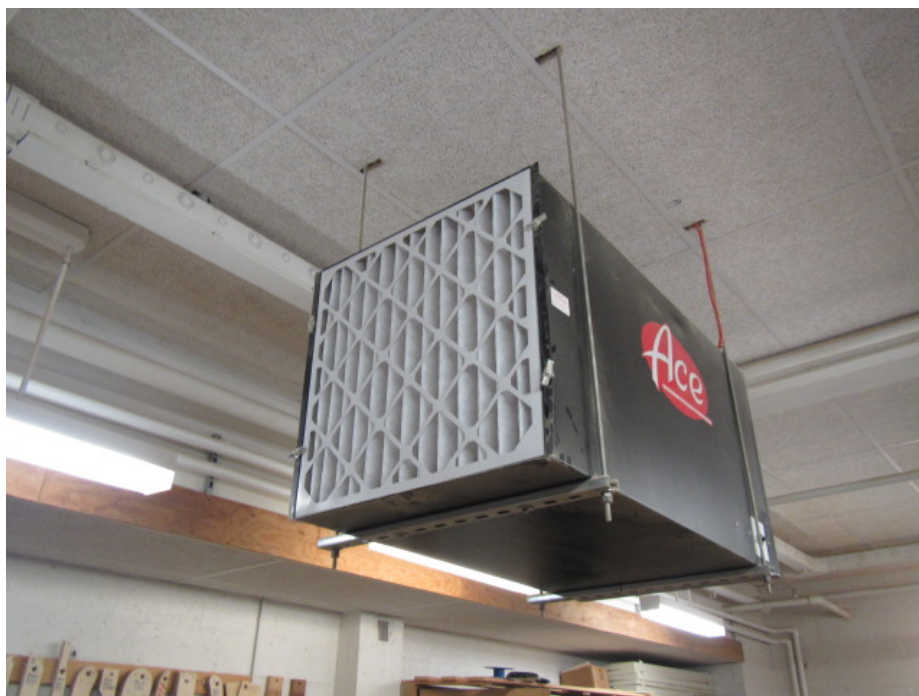
Picture 22

Air filtration unit in woodshop/technology area

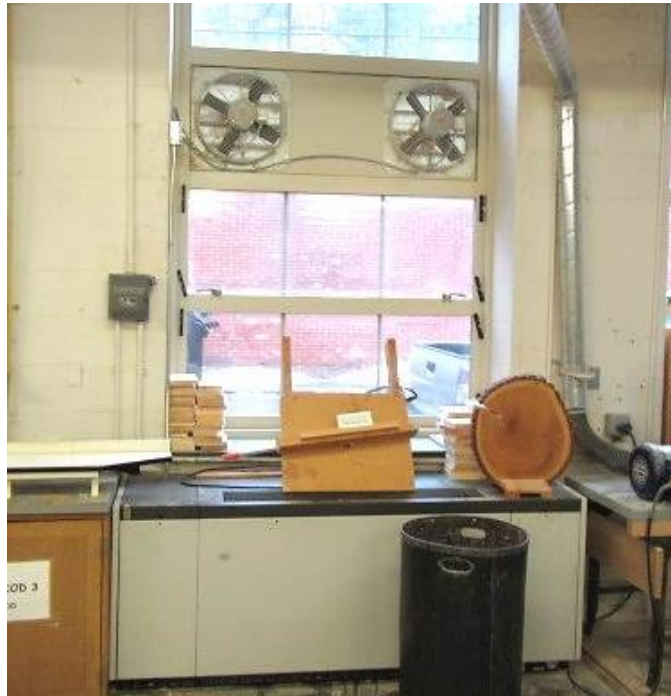
Picture 23

Local exhaust fans in woodshop/technology area

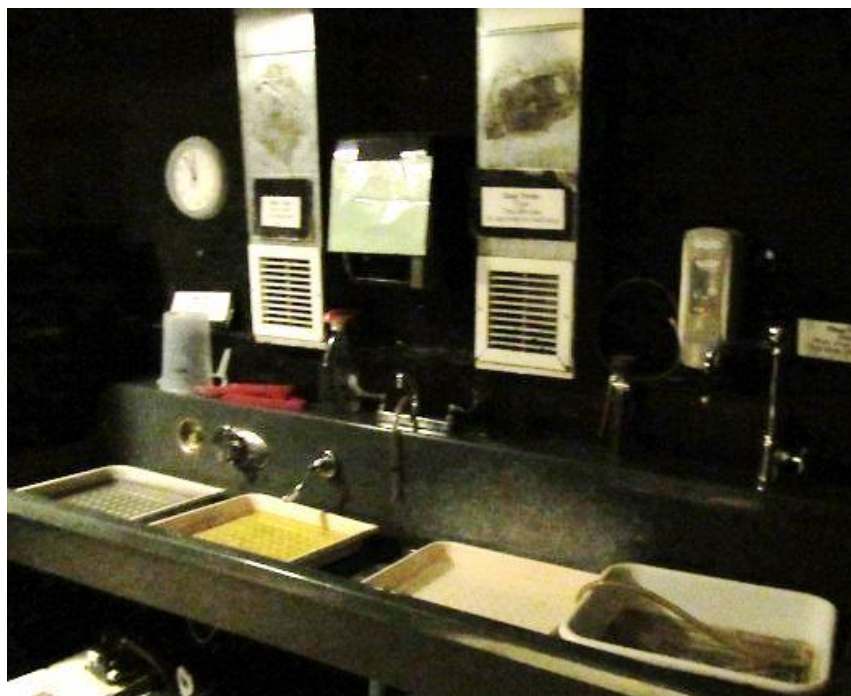
Picture 24

The photography area also has several different ventilation components. The Darkroom itself has local exhaust vents located directly over chemical developing areas (Picture 24), which were operating at the time of assessment. Photography room B had an air filtration unit installed in the ceiling, which was not in use at the time of assessment. It was not clear what the function/capabilities of this unit were (e.g., able to filter out airborne photography chemicals). This unit did not appear to exhaust to the outdoors (i.e., remove airborne pollutants) but rather draws air into a filter and recirculates back into the room.

Local exhaust vents located over developing area in Darkroom

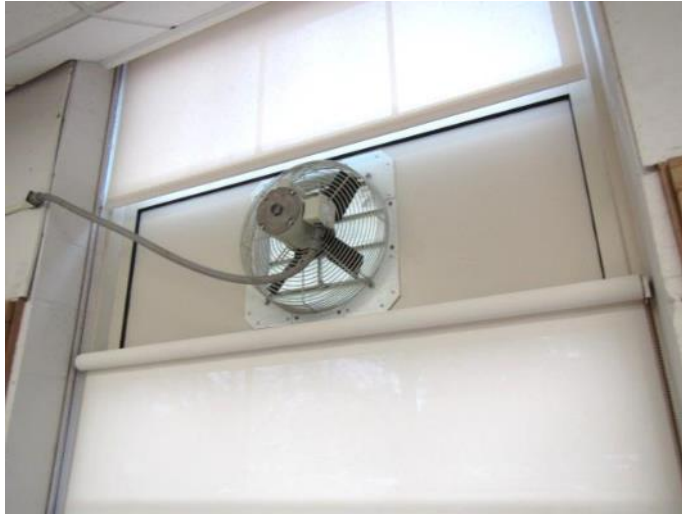
Picture 25

Art room 304b contained a kiln that was outfitted with local exhaust that vents directly outdoors. It was also reported that students occasionally perform soldering work. In the past, the majority of soldering compounds contained lead. Art staff should ensure that any soldering compounds used are environmentally friendly/lead-free products. In addition, local exhaust fans located above work stations (Picture 25) should be activated during soldering as well as any other odor or dust producing activities.

Local exhaust fan in Art room 304b near soldering station

22. Determine the use/function of air filtration unit in Photography room B.
23. Ensure local exhaust vents/fans for kiln and other fume/dust producing activities are operating to reduce/prevent exposure to airborne pollutants.
